Building Condition Assessment For Almonte Branch Library

The Town of Mississippi Mills

Project No. 60310532

June 10, 2014

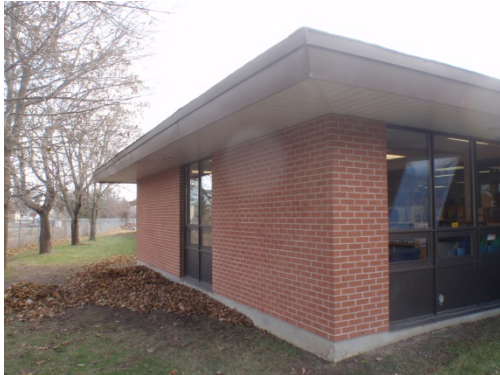
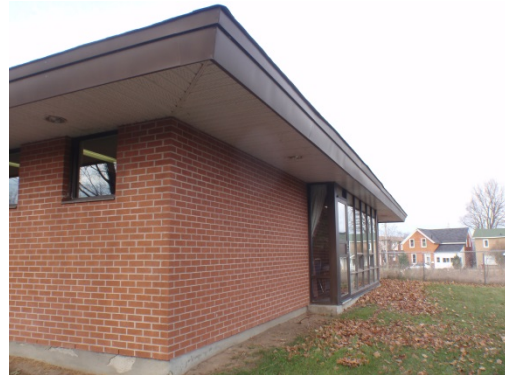
Condition / Deficiencies: The foundation parging visible at grade has spalled at some locations.

Recommended Work: Monitor parging for increases in spalls or evidence of hairline cracks.

Budget Replacement / Repair Cost: Monitoring is part of site maintenance.

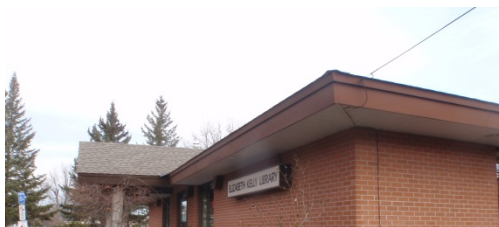
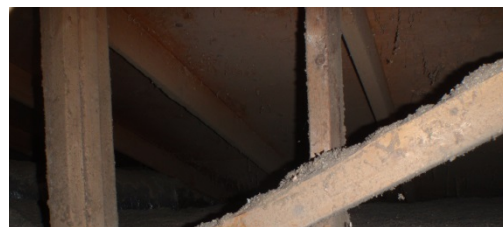
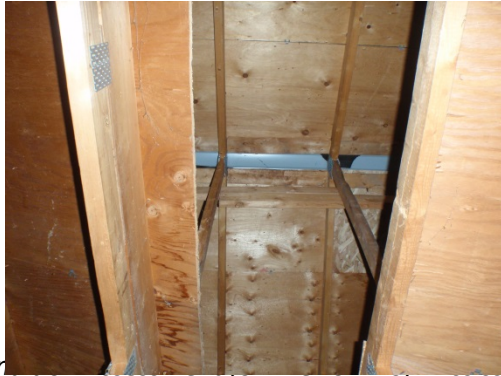
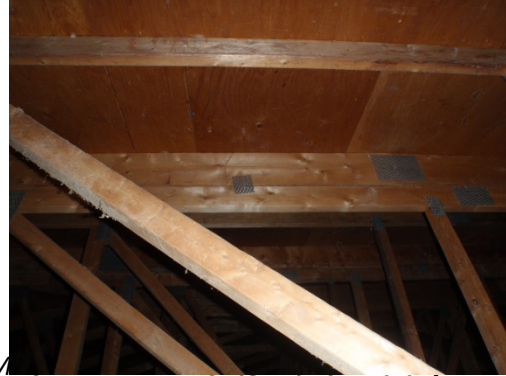
Condition / Deficiencies: The structural systems appear to be in Good Condition.

Recommended Work: Monitor seasonally for indications of movement including hairline cracks in exterior wall finishes.

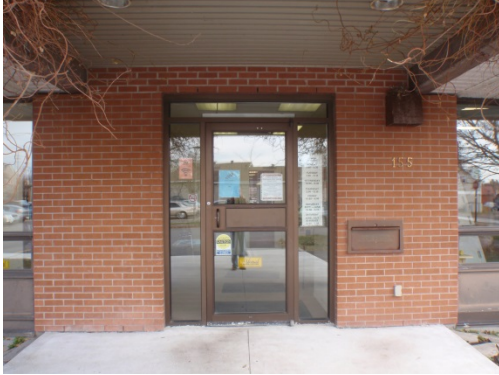
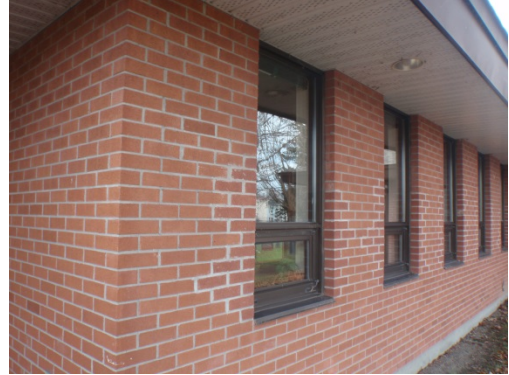
Condition / Deficiencies: In general, the envelope components are in Fair to Good condition. Caulking is dried and cracking around windows and doors. Mortar repointing is evident at some locations (refer to photo below).

Recommended Work: Monitor brick and mortar for hairline cracking. Recaulk at all window and door perimeters, at construction joints, and other locations where dissimilar materials adjoin.

Budget Replacement/Repair Cost: Monitoring is part of maintenance. Recaulk within the next 5 years: \$7,000.

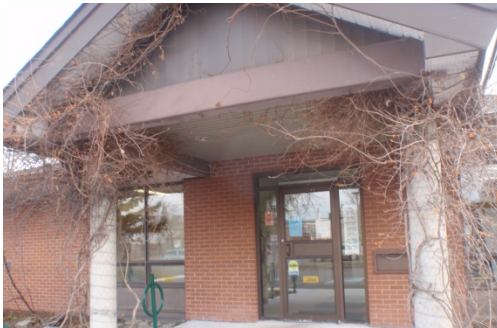
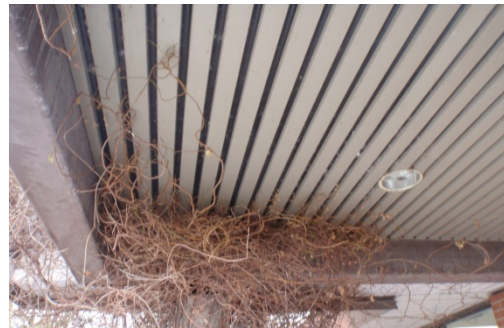
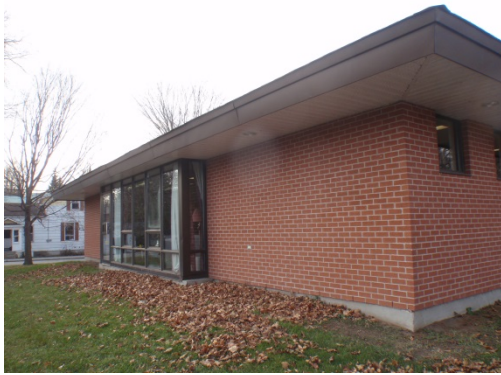
ii) Roof (continued)

Condition / Deficiencies: Fair to Good Condition for all roof systems. Minor damage to the entry soffit and fascia appears to be caused by overgrown bittersweet vines.

The Municipal Building Department reports that ice dams have occurred in the roof and that they are the by-product of a lack of insulation at the lower portions of the eaves. Further detailed investigation of the lower eaves in the attic interior is recommended to develop a long-term solution to this issue.

Recommended Work: Review the lower eaves in the attic in the next year to confirm the types of trusses used, the amount of existing insulation and attic ventilators, and the space available for additional insulation. Replace all roofing in the next 10 years. Include for gutters, downspouts and splash pads to reduce erosion of ground adjacent to the building. Trim bittersweet vines at main entry seasonally to minimize encroachment on soffit and fascia.

Budget Replacement/Repair Cost: \$1500 in the next year for minor repairs to the main entry soffit and fascia. Reserve \$5,000 in the next 5 years for provision of additional insulation and possible ventilators subject to a detailed review of the attic interior at the lower eaves. Allow \$100,000 in the next 10 years for general roofing systems replacement (roofing, flashing, gutters, downspouts and splash pads).

Vine trimming at the main entry is part of general maintenance.

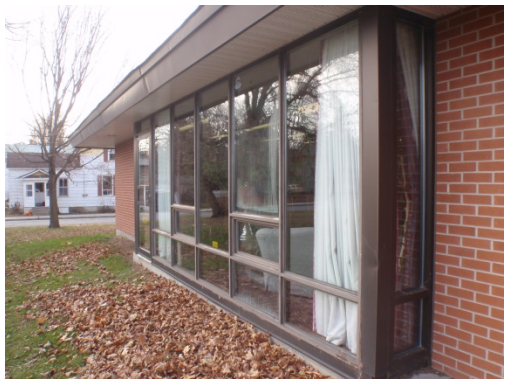
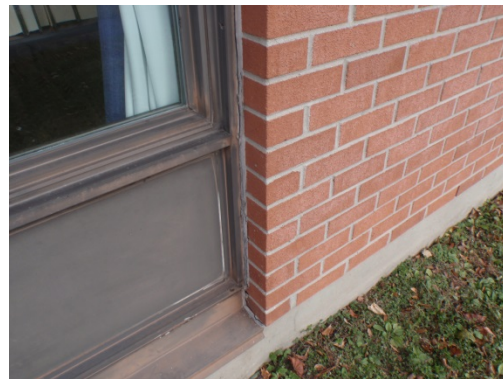
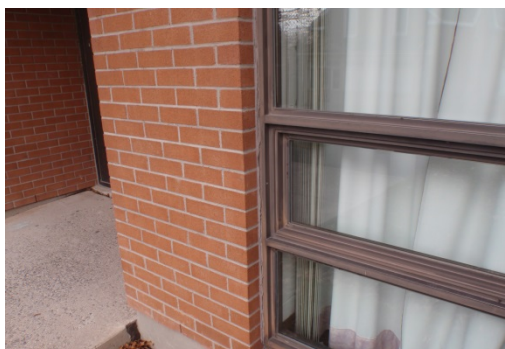
Condition / Deficiencies: Fair condition.

Recommended Work: Caulk seal at perimeters of frames. The cost for this work has been included in Building Envelope – Exterior Walls.

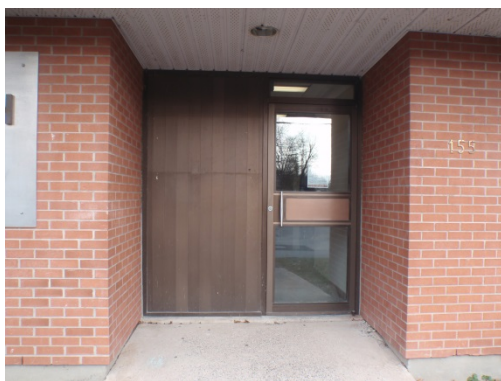
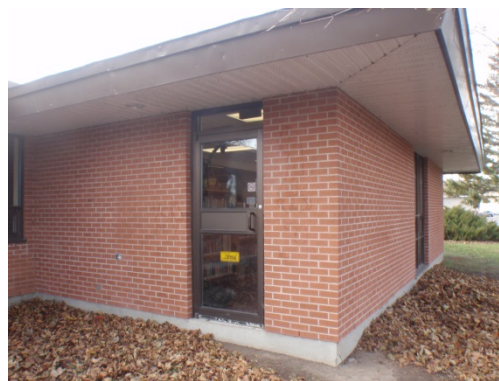
Condition / Deficiencies: The doors, hardware and weather seals are in Fair to Good condition.

Recommended Work: Monitor monthly for damage / deterioration.

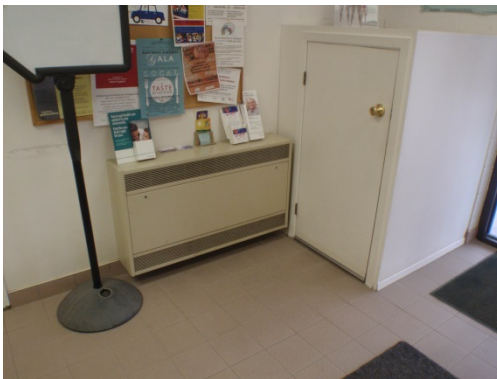
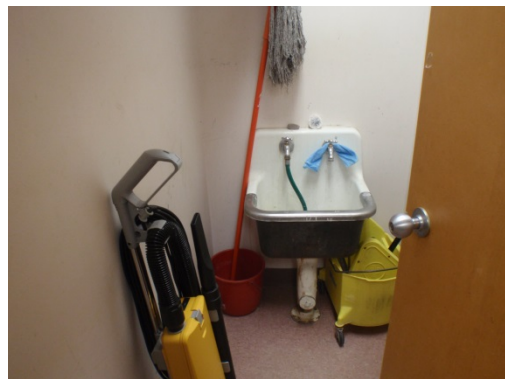
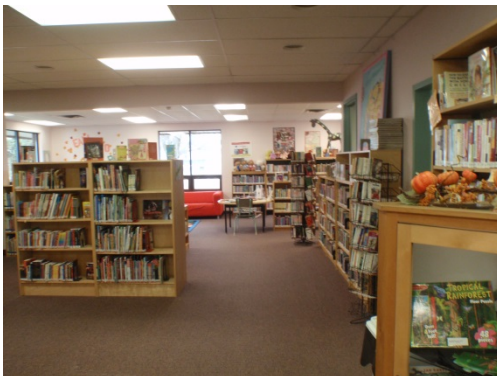
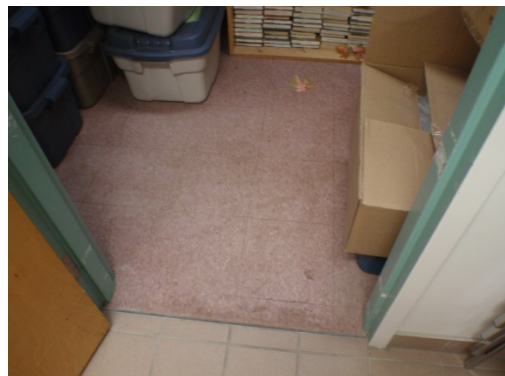
i) Flooring (continued):

Condition / Deficiencies: Fair Condition. Some vinyl tile is worn in storage / service areas). Staff report annual heaving of concrete slab under carpeted areas and rippling of carpet in humid summer weather.

Recommended Work: Replace worn vinyl tile. Allow for carpet replacement in the next 5 years. Monitor and measure slab heaving seasonally to determine extent of movement. Monitor and measure interior temperature and humidity levels seasonally to determine whether levels are outside those generally recommended for libraries with open stack areas. An interior temperature of 20°C and a relative humidity range of 30 – 40% are industry standards and are recommended to be maintained at all times in the building.

Budget Replacement/Repair Cost: Allow for vinyl repair in the next 5 years: \$500. Allow for carpet replacement in the next 10 years: \$50,000. Allow \$3,000 in the next year for monitoring and measuring slab movement and interior temperature and humidity levels.

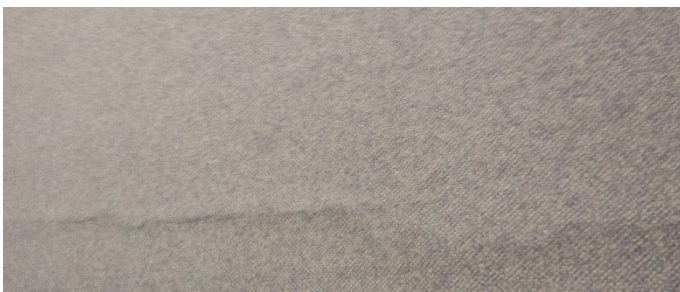
Photograph above: Close-up of carpet with evidence of concrete slab heave below.

Analysis of findings from monitoring and measuring will allow for next steps to be determined with respect to addressing slab movement and rippling of carpet. Budgeting of next steps is beyond the scope of this review. However, slab heaving may be an indication of moisture levels below and in the concrete slab. This condition could be a contributing cause for the rippling carpet during summer. It will be important that both the slab movement findings and the general interior temperature/humidity control findings be reviewed together to assist in determining solutions to managing slab movement, controlling interior temperature/humidity levels, and eliminating the causes for the rippling of carpet.

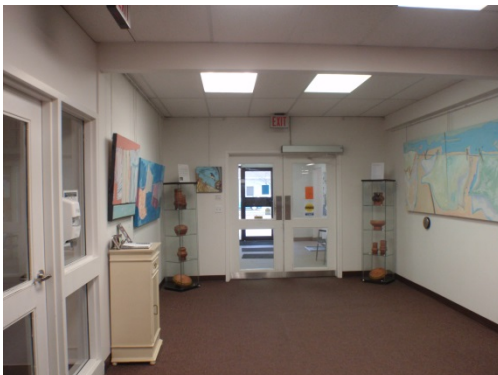
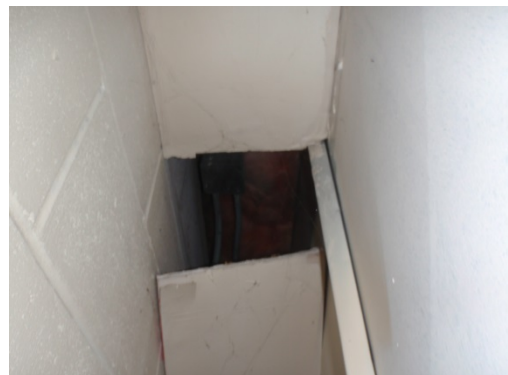
Condition / Deficiencies: Fair condition. Repair damaged gypsum board ceiling in mechanical room to maintain 1 hour fire separation from adjacent interior spaces. (photo below).

Recommended Work: Replace stained tiles as part of maintenance program. Repair gypsum board and repaint within 5 years.

Budget Replacement/Repair Cost: \$1,000 (repair/repaint gypsum board).

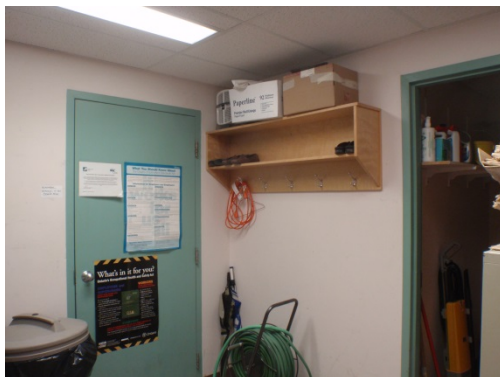
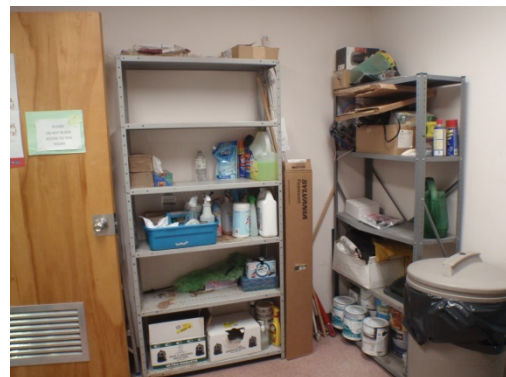
Condition / Deficiencies: Fair to Good Condition.

Recommended Work: Maintain hardware. Allow for resealing of wood doors and repainting of metal doors within 5 years.

Budget Replacement/Repair Cost: \$3,000.

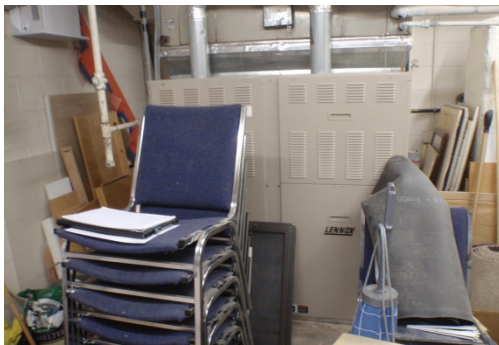
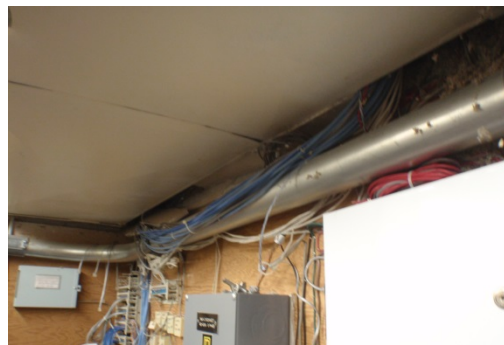
Condition / Deficiencies: It is necessary to maintain a 1 hour fire rating between the mechanical room and adjacent spaces. Refer to Interior Finishes – Walls section and Ceilings section for details and costs for repairs.

Recommended Work: Provision of fire stop in any penetration through the walls (refer to Interior Finishes – Walls) and ceiling (refer to Interior Finishes – Ceilings). Repair gypsum board ceiling to maintain separation. Allow for provision of fire dampers in ducts that travel from the mechanical room to the attic space. Dampers are required to maintain the same 1 hour fire separation.

Budget Replacement/Repair Cost: Fire dampers: \$10,000.

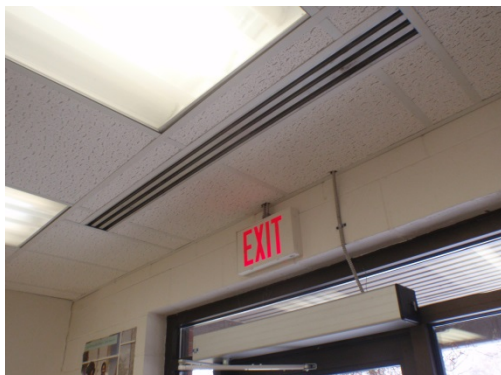
Condition / Deficiencies: Good Condition.

Recommended Work: Test monthly, maintain lamps in signs and allow for replacement within 5 years.

Budget Replacement/Repair Cost: \$6,000.

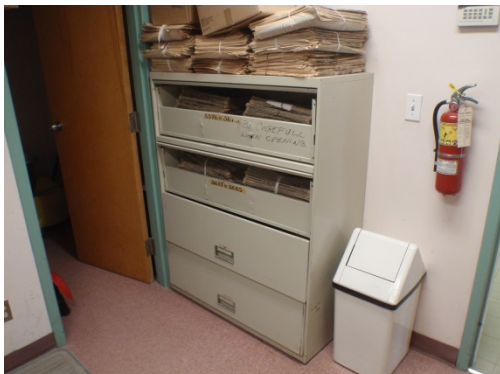
Condition / Deficiencies: Good condition.

Recommended Work: Continue inspections as noted on inspection tags.

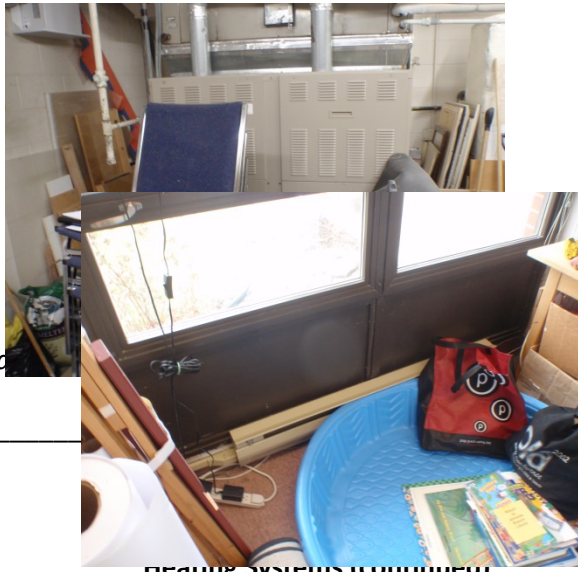
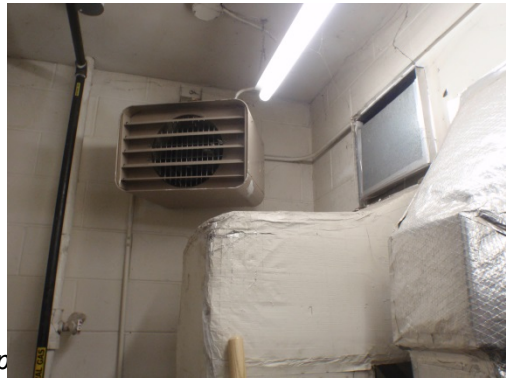
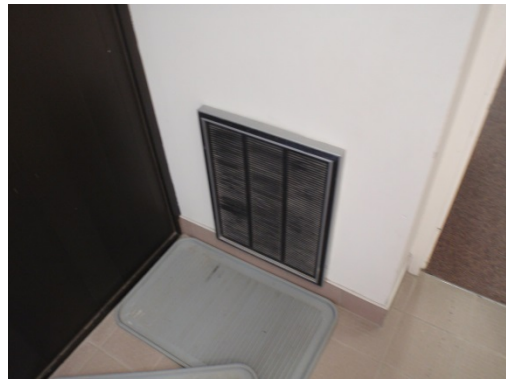
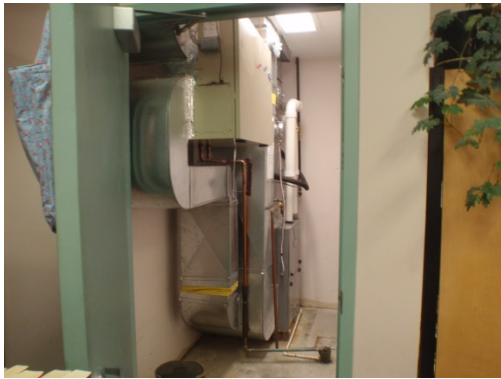
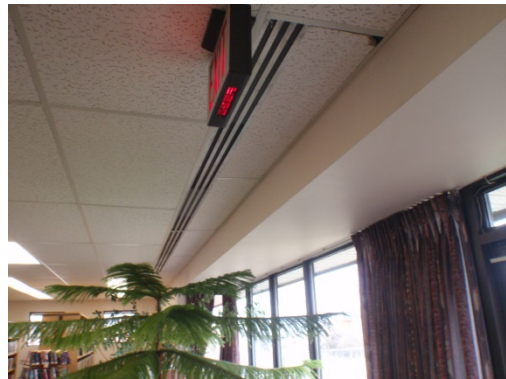
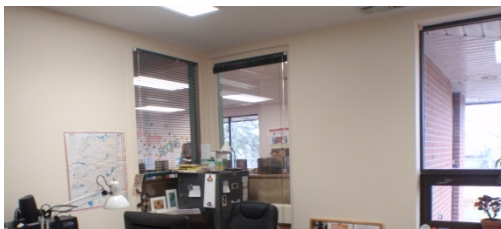
heating systems (continued)

Condition / Deficiencies: Systems are in Fair to Good condition. Portable heaters and fans were noted in central staff areas. Further study is recommended to determine whether repositioning/rebalancing of diffusers is required to address local interior temperatures.

Recommended Work: Allow for replacement of 1980 furnaces in 5 years. Allow for replacement of third furnace, HRV, and other electric heating units in 10 years. Rebalancing study recommended for staff areas (\$5,000 - part of 5 year horizon work).

Budget Replacement/Repair Cost: 5 years: \$35,000. 10 years: \$55,000.

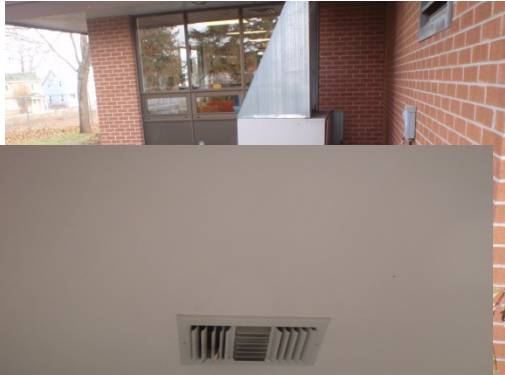
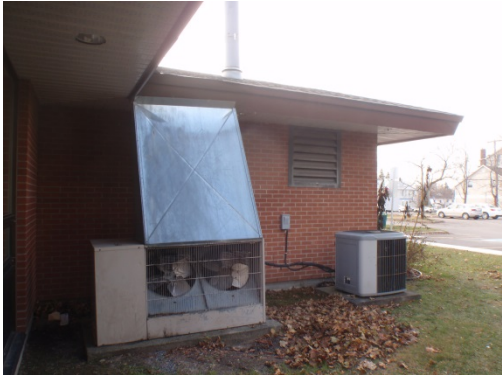
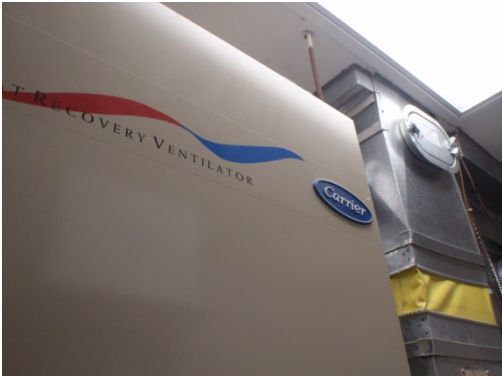
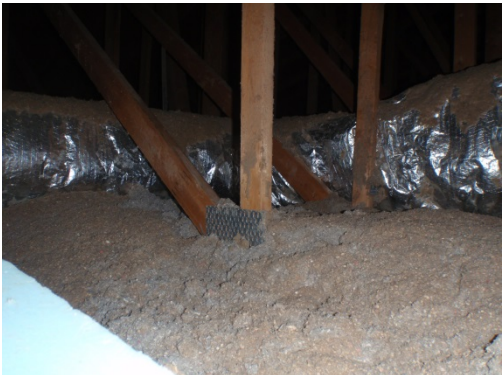
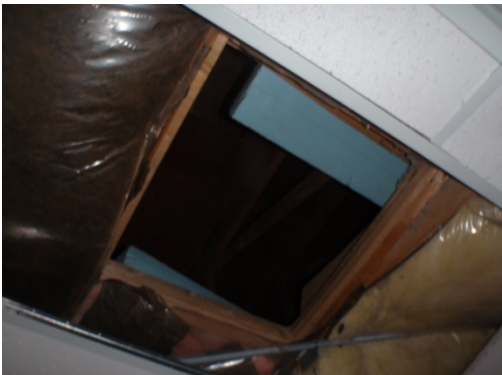
Ventilation / Air Conditioning (continued)

Condition / Deficiencies: The fixtures are in Fair to Good Condition. Openings for ducts from the north west mechanical room to the external condensing units may require additional sealing/insulation to reduce heat loss. A suspended electric unit heater is currently located in this area. This type of heater is normally provided to address local heat loss. Improved sealing and insulation will reduce the requirement for the heater.

Recommended Work: Allow for replacement of the external condensing units in the next 5 years (1980 unit) and 10 years (1996 unit). Allow for replacement of the exhaust fans in the next 10 years. Allow for a study to consider redirection of the exhausts through the existing HRV, or a parallel unit. Allow for study of the staff area for cooling and ventilating needs (cost is included in the study recommended under Mechanical – Heating Systems).

Budget Replacement/Repair Cost: Condensing unit replacements: \$15,000 (5 years), \$10,000 (10 years); exhaust fan replacements: \$10,000 (10 years); study allowance for exhausts to be directed to an HRV: \$5,000 (5 years).

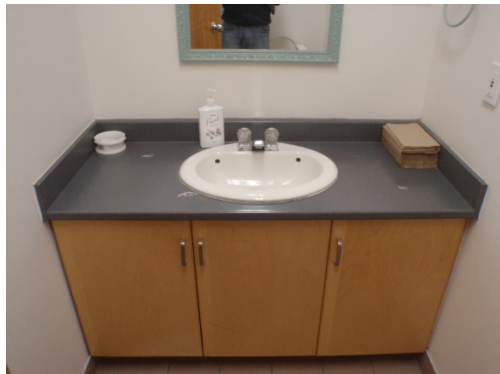
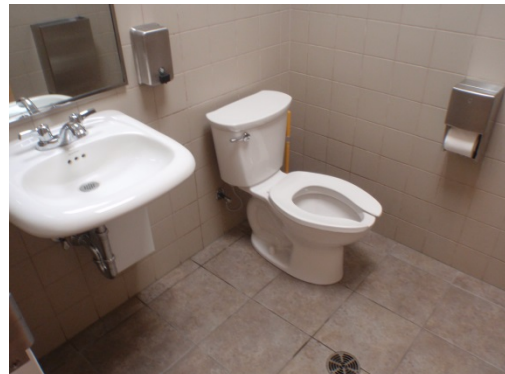
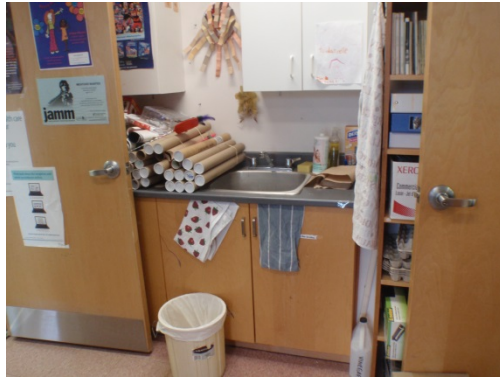
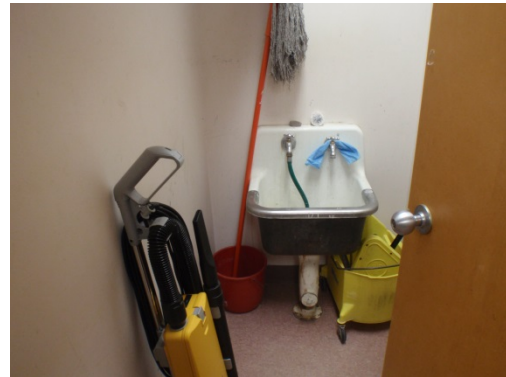
Condition / Deficiencies: The fixtures are in Fair to Good Condition.

Recommended Work: Monitor monthly for leaks from fixtures.

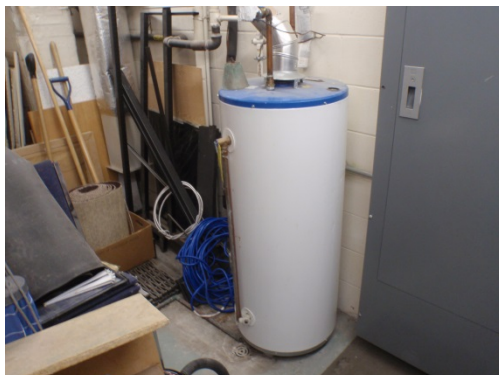
Condition / Deficiencies: Fair Condition.

Recommended Work: Replace within 5 years.

Budget Replacement/Repair Cost: \$2,000.

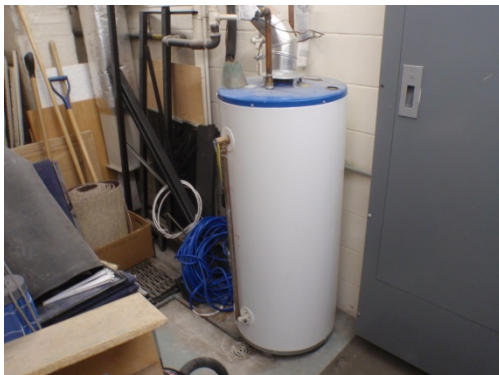
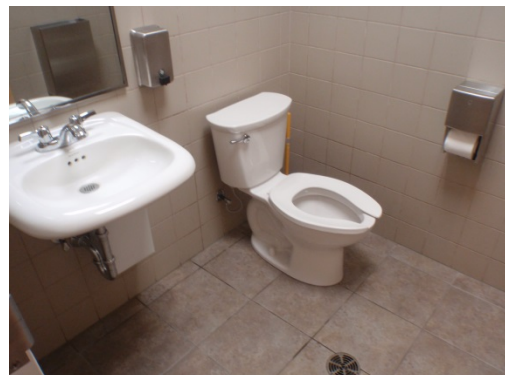
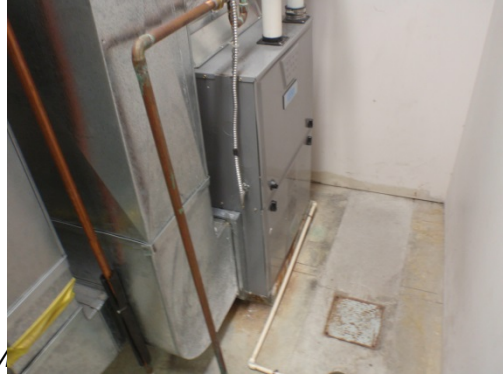
Condition / Deficiencies: Fair Condition. Staff report that traps are not maintaining seals and need to have water added weekly.

Recommended Work: Allow for repair of drain traps to maintain seals. Check traps monthly for trap seal (that traps are primed with water), build-up and clean out.

Budget Replacement/Repair Cost: Allow \$3,000 in the next year for drain repairs. Balance of checking of drains is part of monthly maintenance.

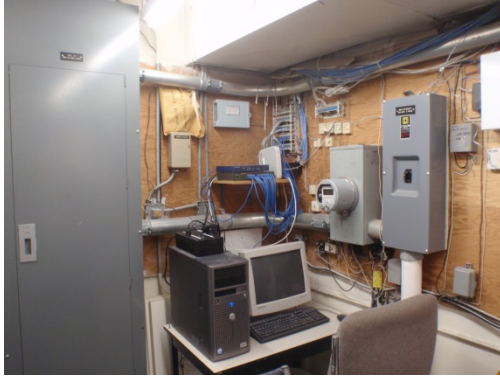
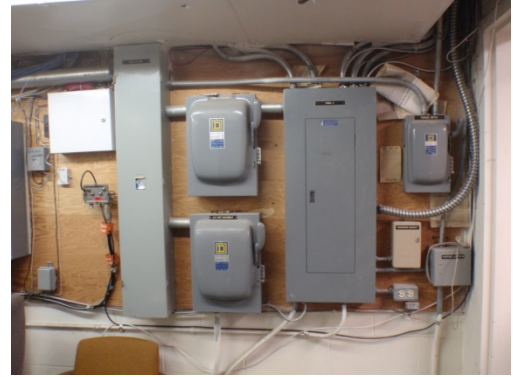
Condition / Deficiencies: Fair to Good Condition.

Recommended Work: Replace original service equipment in the next 10 years.

Budget Replacement/Repair Cost: \$18,000.

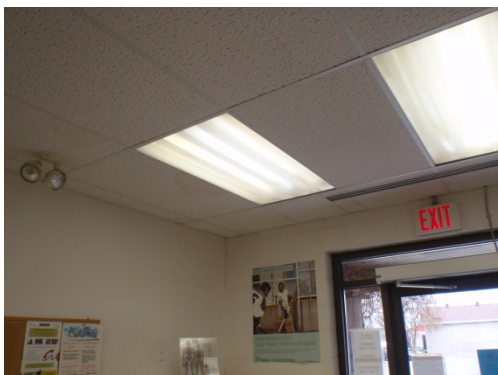
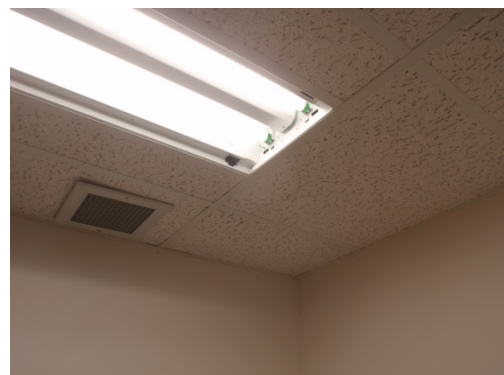
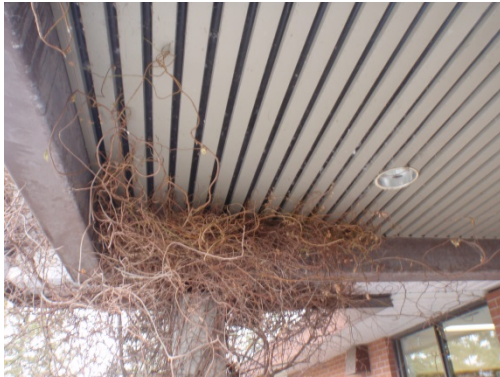
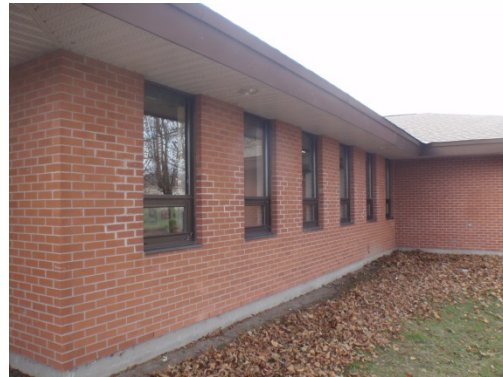
Condition / Deficiencies: Fair to Good condition.

Recommended Work: Replace T8 lamps with T5 lamps (interior). Replace HID fixtures with LED's. Replace incandescent lamps with compact fluorescents.

Budget Replacement/Repair Cost: \$8,000.

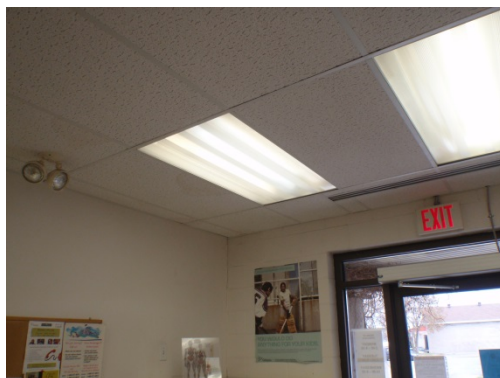
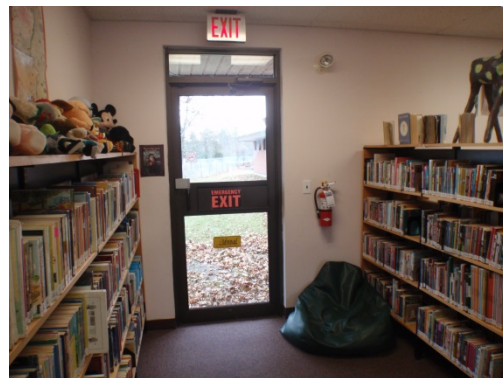
Condition / Deficiencies: Good Condition.

Recommended Work: Test monthly.

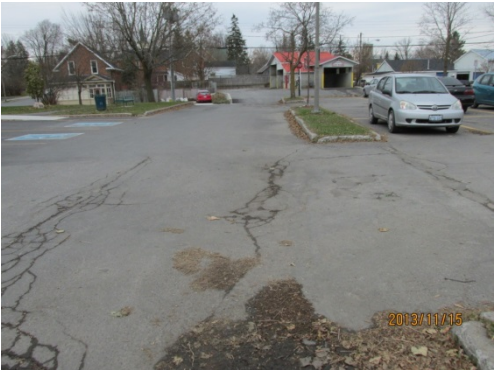
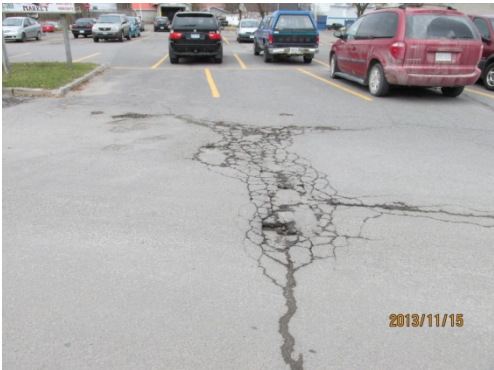
i) Asphalt Pavement (continued):

Condition/deficiencies: The asphalt walkway appears to be in good condition (minor transverse cracks were noted). The asphalt parking lot is in fair condition. The driveway is considered to be in poor condition. The driveway showed fatigue cracking, longitudinal/transverse cracking and potholes in several locations. Depressions, potholes, and longitudinal/transverse cracking were noted in the parking area.

Recommended work: Full-depth replacement of asphalt pavement shows signs of fatigue cracking. Hot mix or cold mix patching of potholes is evident. Placement of an asphalt overlay at depressions was noted to bring asphalt surface to the desired grade. Sealing of longitudinal and transverse cracks with asphalt crack sealer was evident. Reconstructed asphalt should be graded such that storm water runoff is captured by catch basins.

Replacement / Repair Cost: Allow \$2,000 in the next year for documenting locations and extents of sink holes. This information will assist in determining the approach to the pavement and substrate design. Allow \$60,000 for full reconstruction of driveway and overlay/patching/sealing in the parking area.

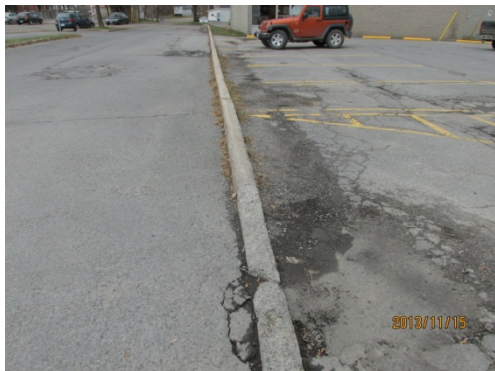
Condition/deficiencies: The concrete sidewalk and accessibility ramp in front of the main entrance are in good condition. The concrete path from the side door to the asphalt walkway is in good condition. The concrete curbs in the parking lot are in poor condition. The concrete path at the side door is separated from the main building floor slab by approximately 60mm. Staff report that the gap is increasing.

Recommended work: Monitor and measure movement of the concrete path reported to be separating from the building floor slab at the side entry. Allow for a revised path section at the building side entry to tie the path slab to the building foundation wall. For the parking area, remove existing concrete curbs and construct new concrete barrier curbs.

Replacement / Repair Cost: Monitoring and measuring in the next year of the path adjacent to the side entry and preparation of details for tying path slab to the building

foundation: \$5,000. Provision of the revised path detail in the next 5 years: \$10,000. Replacement of concrete curbs in the parking area: \$20,000.

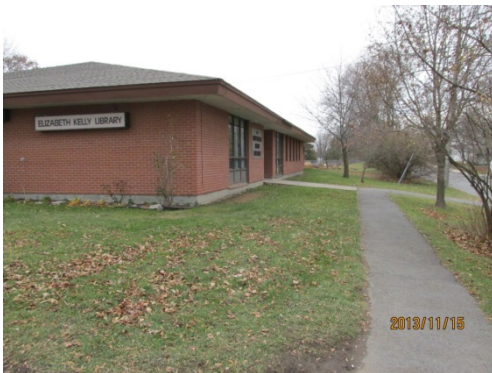
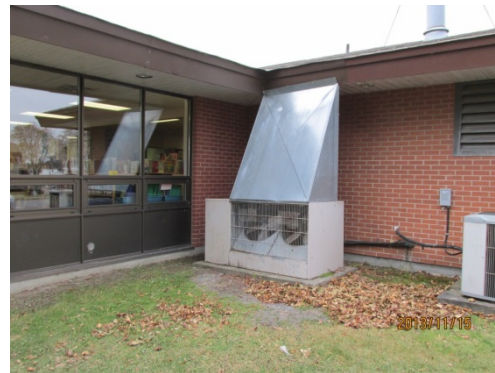
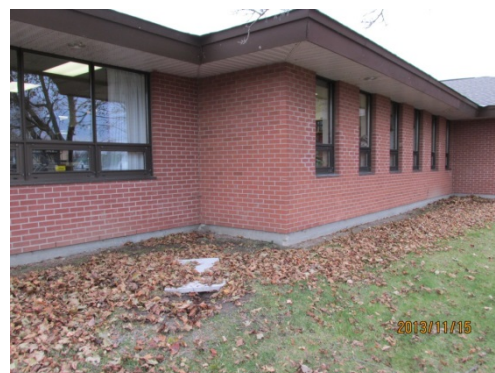
iii) Site Grading and Drainage (continued):

Condition/deficiencies: The library does not have gutters or rainwater leaders. Eroded soils were noted below the rooftop corners, where the majority of storm water runoff is discharged to the grass surface. Concrete pavers are located at most corners to reduce soil erosion. The soils underlying the concrete pad which supports the fans shown in the photograph below had begun to erode due to rainfall runoff from the building roof. In addition, the site grades observed did not appear to direct storm water runoff from the driveway into the parking lot catch basins.

Recommended work: Install gutters along the roof perimeter. Install rainwater leaders and splash pads to direct runoff away from the building and onto the grassed surface. Consider constructing new catch basins in the driveway to capture storm water runoff and direct into the existing storm sewer system.

For the parking lot, monitoring and measuring of rainwater retained in the parking lot during heavy summer rains is recommended. The findings will assist in determining measures for managing the storm flow in the future.

Replacement / Repair Cost: \$12,000 (parking lot drainage). Refer to Building Envelope – Roof for costs related to gutters, downspouts and splash pads. Allow \$3,000 for monitoring and measuring storm flow in the parking lot, and providing recommendations for storm flow management.

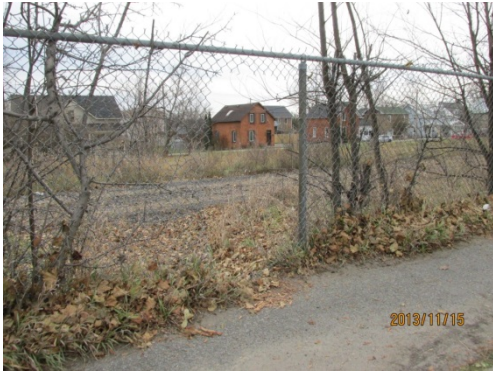
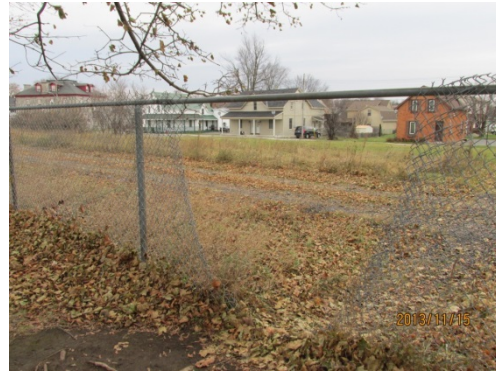
Condition/deficiencies: Two openings in the fence between the former railway tracks and the library were noted. These openings appeared to have been cut with wire cutters, which exposed sharp steel chain link wires (safety hazard). With the exception of these openings, the chain link fence appears to be in good condition.

Recommended work: Remove and replace the damaged chainlink fence to close off the two openings. If access between the former railway tracks and the library are required, consider installing chainlink fence gates in the vicinity of the openings noted. Work is subject to confirmation that the fence is owned by the Municipality.

Replacement / Repair Cost: < \$3,000
