2018-05-04

FSA Project #: 18058CO

Subject: **Thermographic Investigation
Almonte Public Library
155 High Street, Almonte**

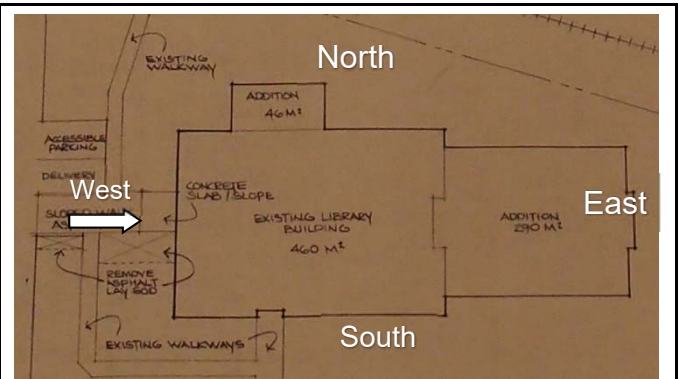
- FSA commenced the thermographic scan on the west elevation (indicated by the write arrow).
- We then continued to the south side and subsequent elevations in a counter-clockwise pattern.
- FSA scanned the entire building, only images of significance have been highlighted in this reporting.

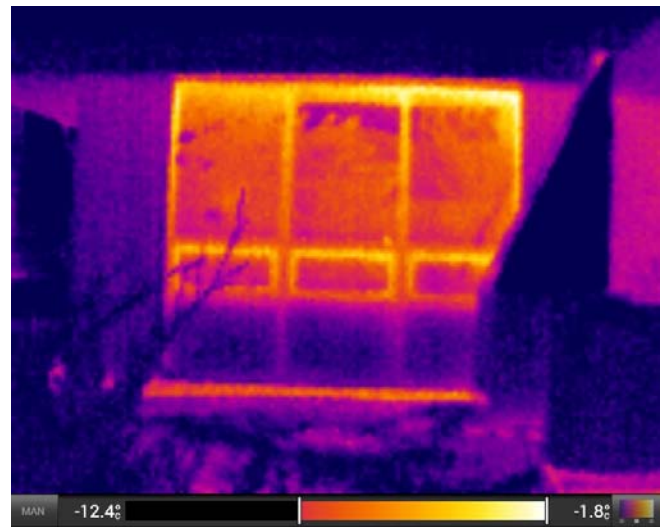
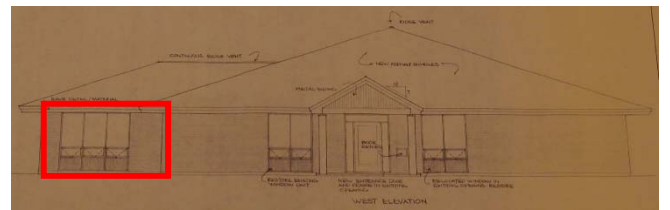
West Elevation:

- This image was taken on the northern end of the west elevation, indicated by the red outline.
- The properties of this image are considered to be fairly typical for this building.
- The warmer spots in the window assembly range from -7°C to -3°C . The wall assembly -11°C to -9°C .
- This range was taken as the building's base point and was used as reference for the remainder of scan.

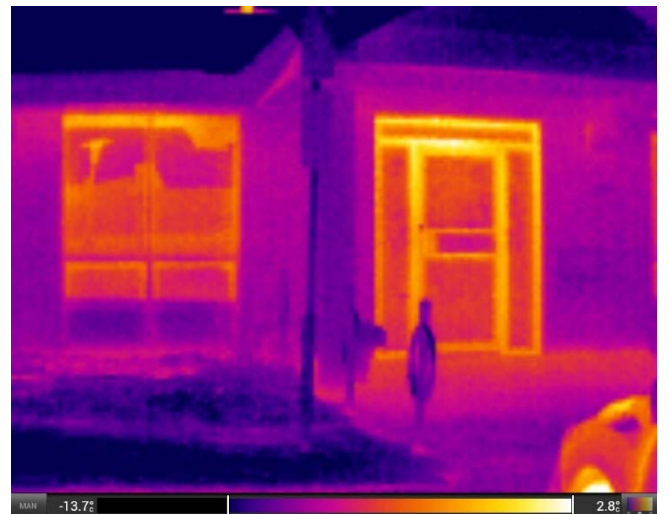
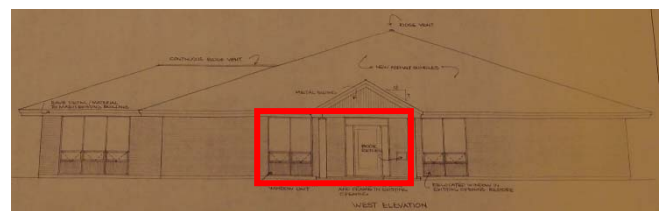
- The wall assembly in this image was found to be within the normal range.
- The window assembly to the left is also exhibits a typical range.
- The door way range is from -7.5°C to 2.8°C , indicating heat loss through the door assembly.

- Review window and door systems to determine if any corrective measures, such as replacement of weatherstripping, gaskets, seals, shim space insulation will improve the situation and correct as required. Apply insulation and parge coating over observed “hot spots” on exterior foundation wall/slab edge.

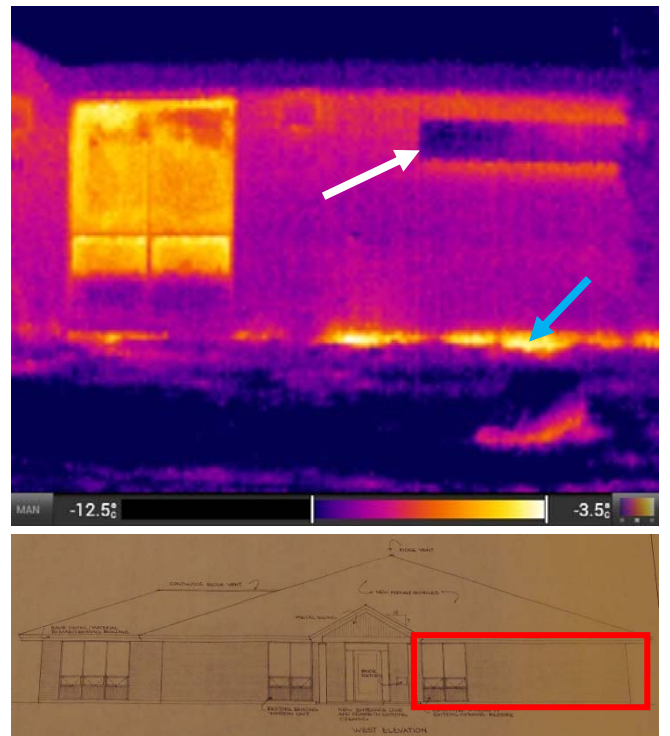
- The window and wall assembly are within the established normal range.
- The exposed portion of the foundation wall (indicated by the blue arrow) is within a range of -6.7°C to -4.2°C .
- This range will be used as reference for the remainder of the report.
- The inconsistent pattern indicated by the white arrow is caused by a wall-mounted sign.

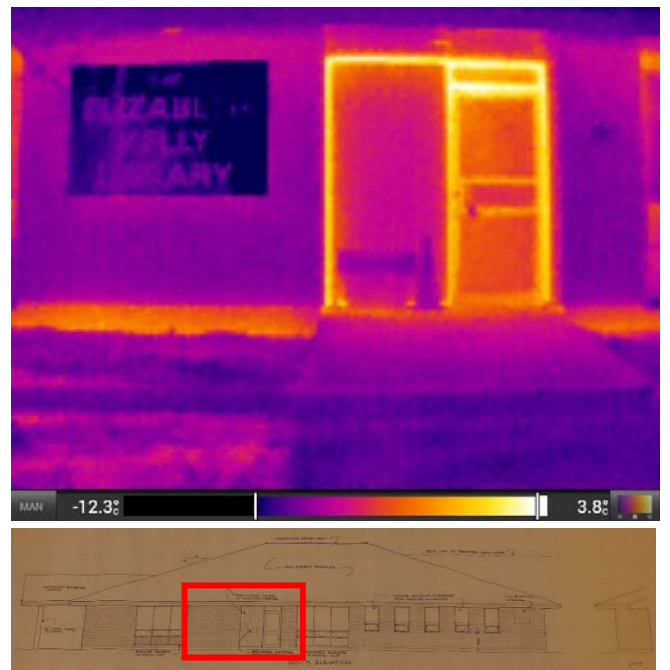
South Elevation:

- The wall assembly is within the established range.
- The foundation wall gets as warm as -2.2°C .
- Similar to above, the door assembly exhibited readings as warm as 4°C .

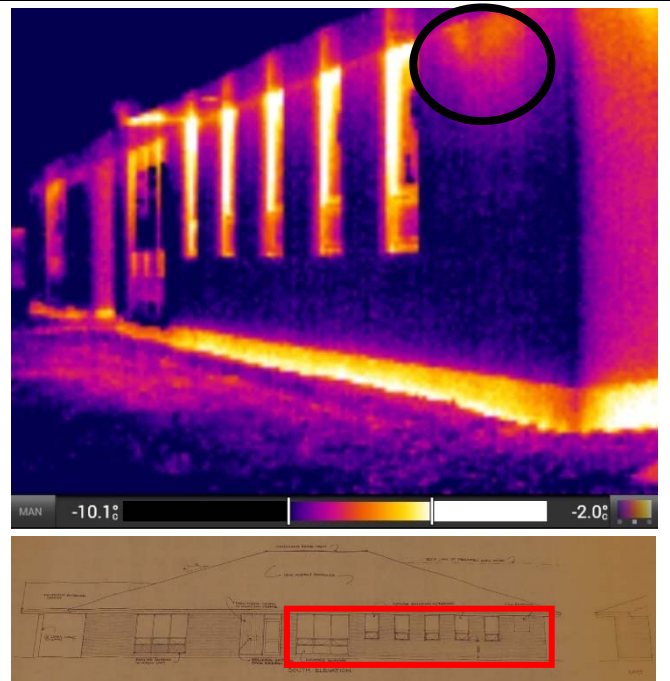
- The top portion of the window assembly has readings as warm as 3.3°C, this is an indication of heat loss.
- The upper portion of the wall assembly has an inconsistent thermographic pattern, indicated by the circle. See next section for comments.
- The foundation wall has readings as warm as -1.5°C.

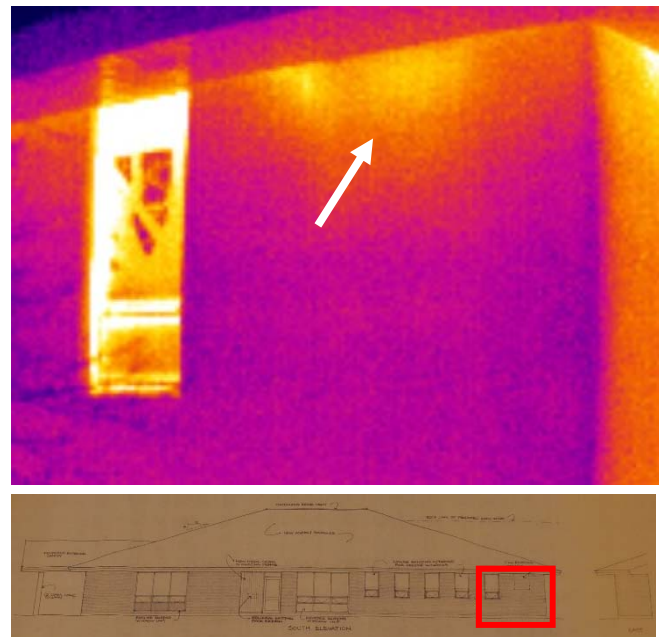
- This image is a close-up of the previous item and occurs right at the southeast corner.
- The lower portion of the wall assembly is within the typical range.
- The upper portion of the wall assembly has readings as warm as -4°C (white arrow).
- This anomaly is characteristic of extraneous air leakage at the wall/roof interface which may be due to a breach in the air barrier membrane or conduction of heat from displaced/absent insulation at this location.

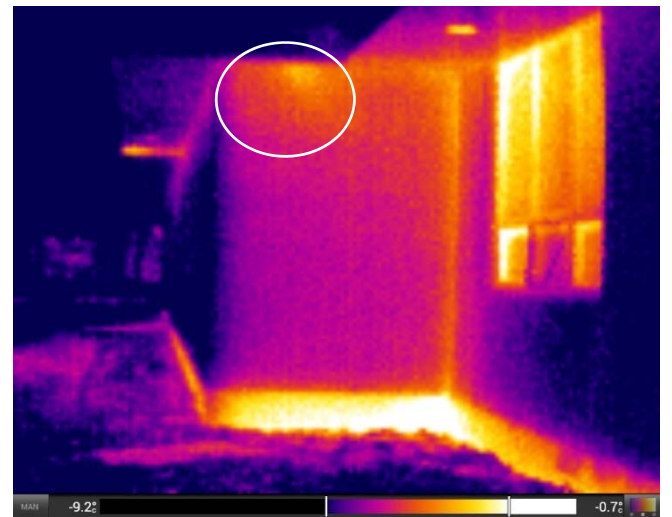
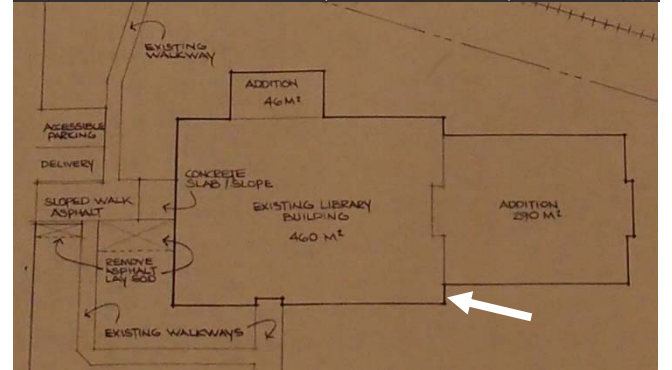
East Elevation:

- This image shows the southernmost partial east elevation of the building, where the addition and original building connect (arrow).
- Like the thermographic image above in the previous item, there is a warmer anomaly in the upper portion of the wall assembly (circle). This anomaly gets as warm as -3.2°C .
- As noted above, this anomaly is also characteristic of extraneous air leakage at the wall/roof interface which may be due to a breach in the air barrier membrane or conduction of heat from displaced/absent insulation at this location.
- The warm area at the inside corner of the slab-on-grade is considered typical for this type of configuration and construction method.

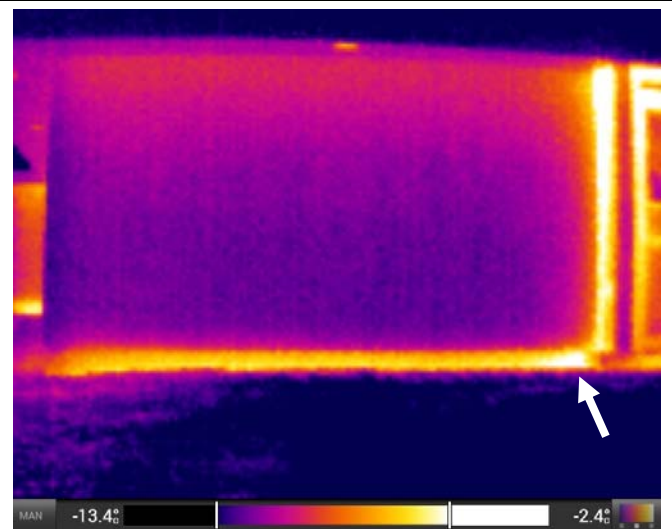
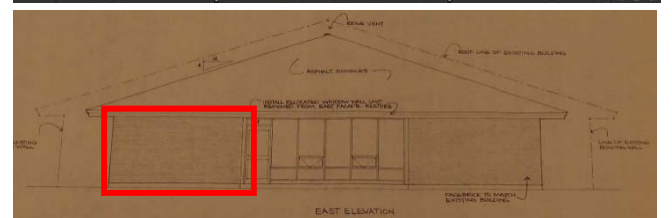
- This portion of wall is situated on the predominant east elevation.
- The wall assembly in this image is within the established range.
- The foundation wall is within the established range; however, started to increase in temperature as you approach the door assembly (arrow).
- The door assembly gets as warm as 2.4°C . This is an indication of heat loss.

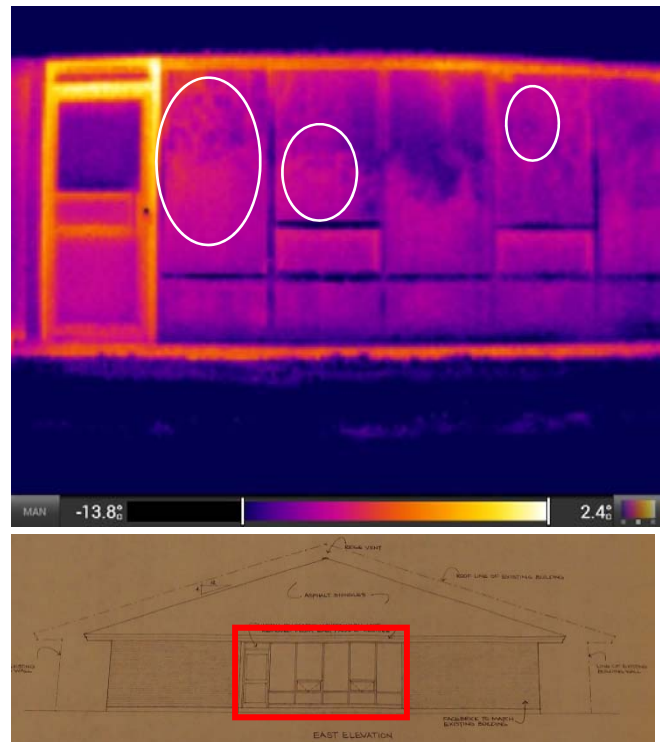
- The window assembly and exposed portion of the foundation wall are within the established range.
- The door assembly is typical for this building, with readings as warm as 2.8°C.
- Very faint warmer areas noted on the glazing (circles) may be an indication that the hermetic seals of the insulated glass units are beginning to fail.

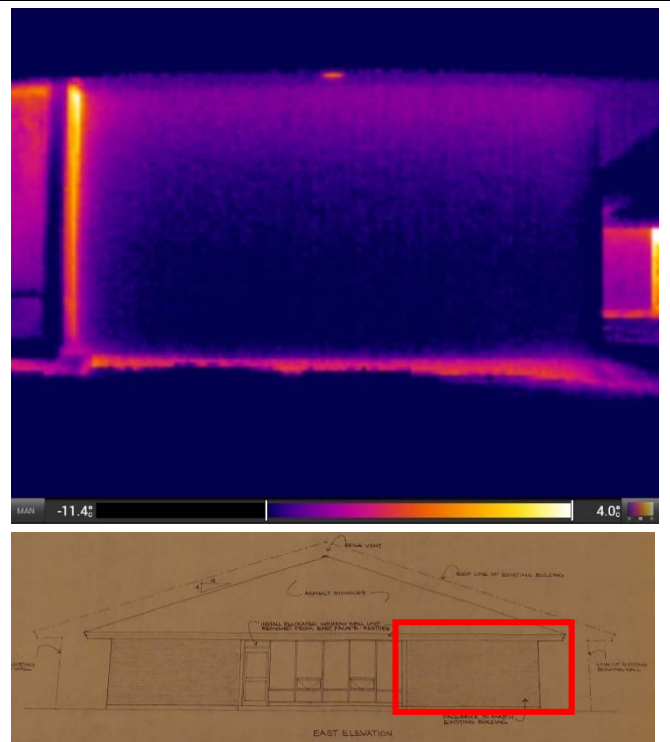
- Similar to above, the wall assembly and exposed portion of the foundation wall are within the established range.
- The door assembly is typical for this building, with readings as warm as 3.4°C.

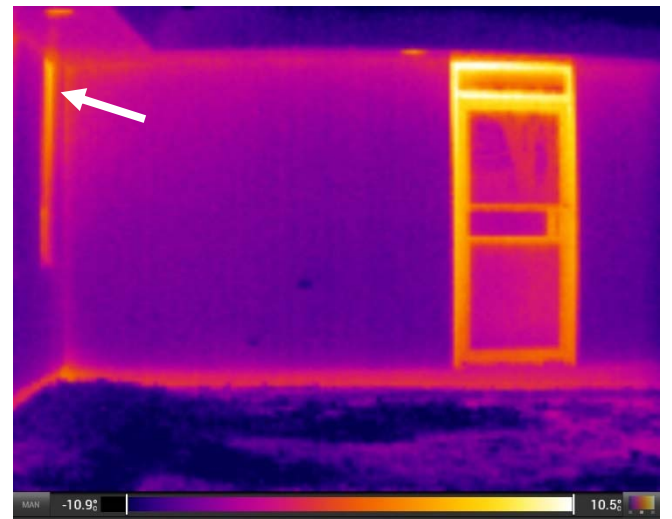
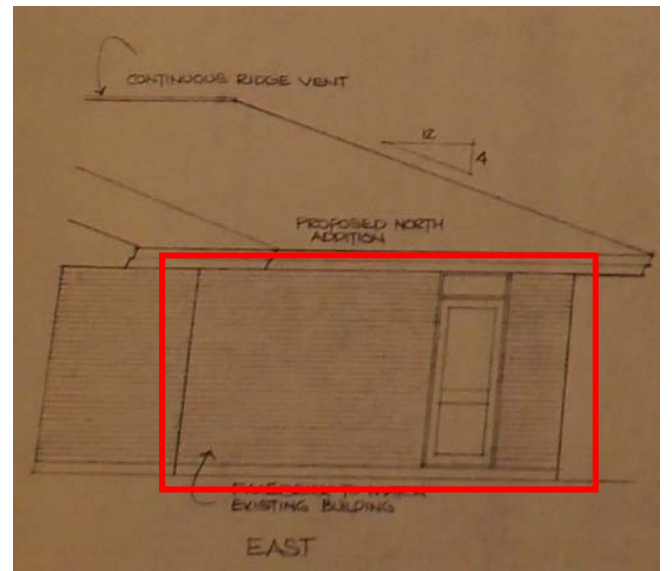
- This image shows the northernmost partial east elevation of the building (i.e., the east elevation of the north addition).
- The foundation wall has readings as warm as -1°C .
- The wall assembly is within the established range, except for the upper left corner with a reading as warm as -1.8°C (arrow).
- This is where the addition and original building connect. There could be a lack of insulation or inconsistent air/vapour barrier tie-in at time of construction.
- The door assembly shown in this image has major heat loss, readings as warm as 10°C .

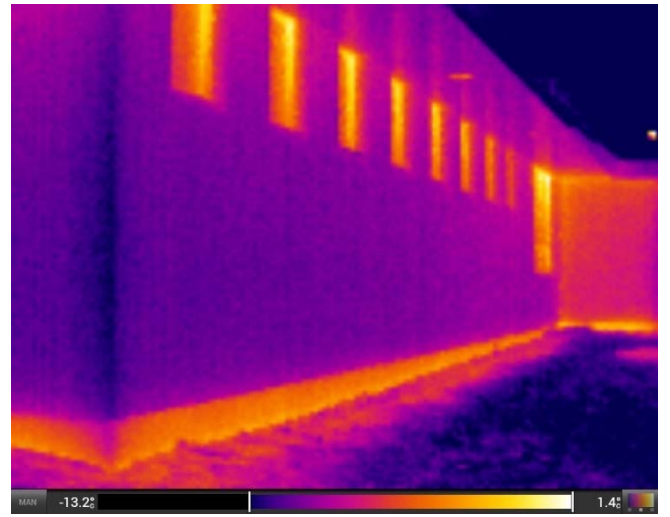
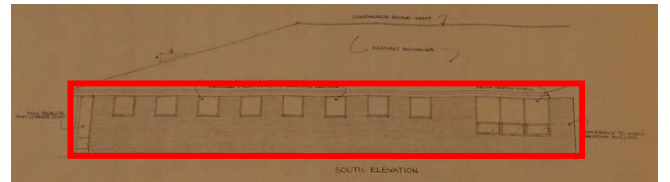
North Elevation:

- FSA noted that the original drawing is mislabeled, as labeled South elevation clearly depicts the North elevation.
- Like the elevation on the south side, the upper portions of the windows have readings as warm as 0°C.

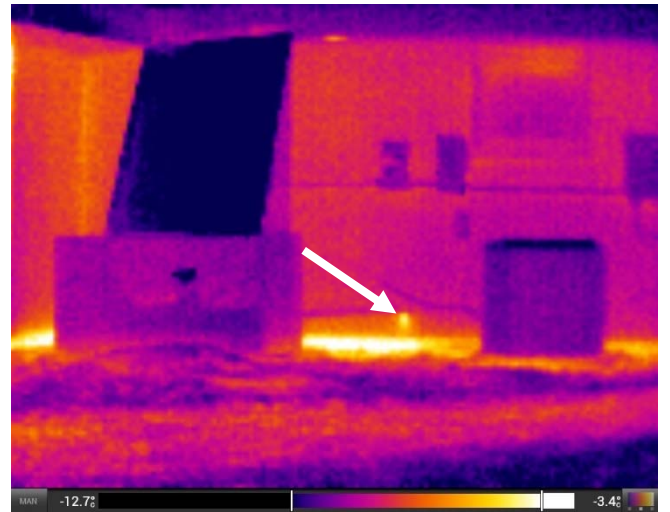
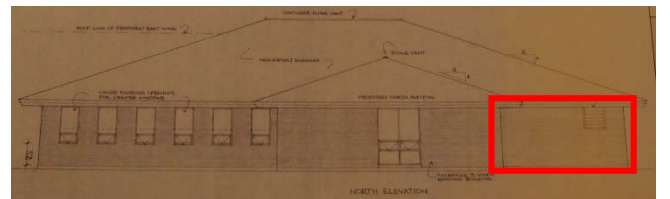
- Overall, wall surfaces in this image are within the established range.
- However, an anomaly was observed and is indicated by the arrow, further investigation is required to determine the cause of this. As there are a few mechanical units in this location, the noted anomaly could simply be a through-wall service penetration that is inappropriately sealed.
