Building Condition Assessment For Almonte Branch Library

The Town of Mississippi Mills

Project No. 60310532

June 10, 2014

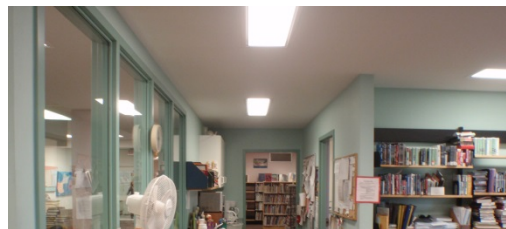
Description: General ventilation / air conditioning is provided in conjunction with the furnaces and HRV described in the Mechanical - Heating Systems. External ground-mounted condensing units are located at the north west corner of the building. Separate exhausts are provided for washrooms, utility room and kitchenette.

Condition / Deficiencies: The fixtures are in Fair to Good Condition. Openings for ducts from the north west mechanical room to the external condensing units may require additional sealing/insulation to reduce heat loss. A suspended electric unit heater is currently located in this area. This type of heater is normally provided to address local heat loss. Improved sealing and insulation will reduce the requirement for the heater.

Recommended Work: Allow for replacement of the external condensing units in the next 5 years (1980 unit) and 10 years (1996 unit). Allow for replacement of the exhaust fans in the next 10 years. Allow for a study to consider redirection of the exhausts through the existing HRV, or a parallel unit. Allow for study of the staff area for cooling and ventilating needs (cost is included in the study recommended under Mechanical – Heating Systems).

Budget Replacement/Repair Cost: Condensing unit replacements: \$15,000 (5 years), \$10,000 (10 years); exhaust fan replacements: \$10,000 (10 years); study allowance for exhausts to be directed to an HRV: \$5,000 (5 years).

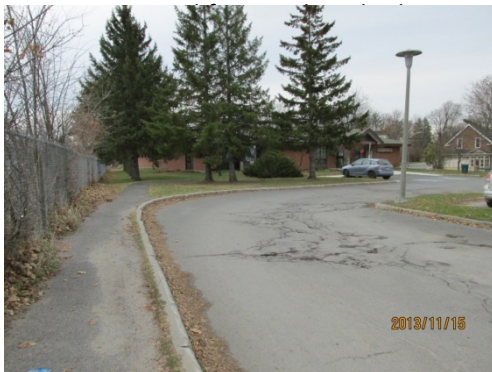
Description: Power is supplied by the Ottawa Power Corporation (generated by the Mississippi River Power Corporation) to the facility.

The outdoor parking lot is lit by two light standards. The library entrance is lit by wall-entrance.

Recommended work: N/A
